Three-dimensional imaging from laser scanner, photogrammetric and acoustic non-destructive techniques in the characterization of stone building materials

In this work we survey the pillars located inside the nineteenth century building named Exmà (Exhibiting and Moving Arts) in the historical city center of Cagliari – Italy. In the nineteenth century it hosted the municipal slaughterhouses; it has now been transformed into a cultural center home to contemporary art exhibitions. The survey has developed through the combination of high resolution Digital Color Images (DCI) and Terrestrial Laser Scanner (TLS) data for a dense 3-D reconstruction of an ancient pillar. This kind of information was effectively used as a valid complement to the ultrasonic 3-D tomographic reconstruction of the pillar.

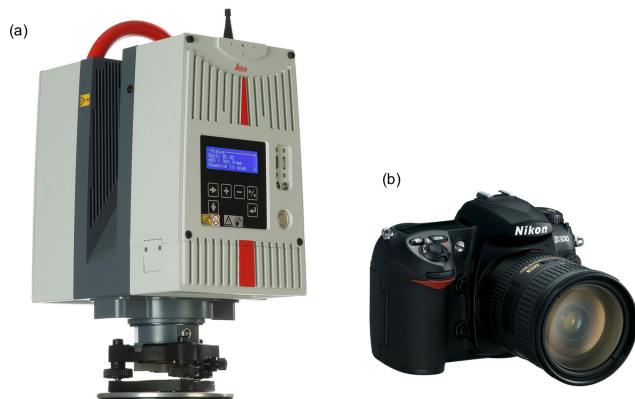
Figure 1. (a) The Leica HDS-6200 TLS; (b) the digital reflex camera Nikon D300 used in this work.

An integrated multi-step procedure is presented here aimed to produce high resolution 3-D models of architectural elements of ancient historical buildings with the integration of TLS and high resolution Photogrammetry (Figs. 1a, b, 2) that can be schematized in the following steps: TLS survey planning and execution, TLS data processing, Photogrammetric survey planning and execution, images gathering, alignment, registration and conversion to texturized point cloud, construction of integrated 3-D model, final computation of geometrical anomalies (Fig. 3, TLS processing with JRC-3-D Reconstructor[®], and Cloud Compare, digital image processing with Agisoft Photoscan[®]). In particular, after an examination of the target object, the TLS survey was scheduled to search the appropriate sites to set the station points in order to obtain more scans of the same object. The survey was made with a Leica HDS-6200 long-range phase shift terrestrial laser scanner (Fig. 1a). Every station point cloud was rotated and translated with respect to every other cloud and one of them was used as an intrinsic reference system (IRS) in order to compute an aggregated 3-D cloud faithful to the real object. Each point of the cloud carries information about the position (XYZ) and the reflectance, a parameter between 0 and 1 representing the ratio between the emitted and reflected phases of the laser wave (Van Balen, 2017).

The TLS technique was supported by automatic photogrammetry in order to obtain a corresponding digital metrically correct color image of the study pillar. About 50 photos were taken by a digital reflex camera to get an almost complete 360° sequence of pictures to ensure a large overlap between images. The three-dimensional model was assembled combining, by a specific software, a set of 2-D high resolution color images captured on the investigated architectural element from multiple viewpoints using a digital 2-D camera (Fig. 1b). The final high resolution color 3-D model (Fig. 2)

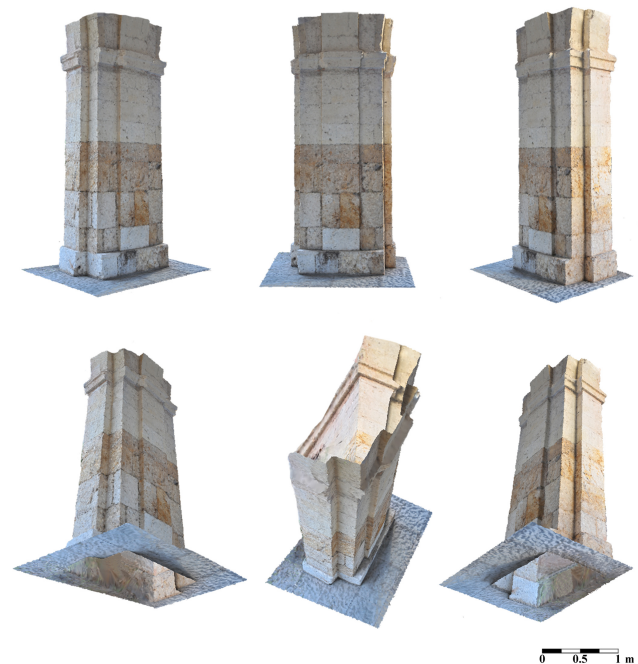
Figure 2. Final high resolution color 3-D model of the investigated pillar reconstructed with the DCI photogrammetric technique: different views points of the pillar reconstructed with the DCI photogrammetric technique.

reproduces a faithful scale copy of the analyzed structure and can therefore be effectively associated with the surface geometric anomalies and the reflectivity values analyzed by the Laser Scanner technique. The flow chart of the survey is shown in Fig. 3. The point clouds elaboration process can be summarized as follows: point clouds input and format conversion, point clouds pre-processing and automatic filtering or manual editing with the elimination of data out of tolerance and unusable points, cloud to cloud draft alignment and fine registration with interactive closest point (ICP) algorithm, cloud aggregation, 3-D modeling and computation of morphological maps, output in dxf format suitable for input on AutoCAD[®].

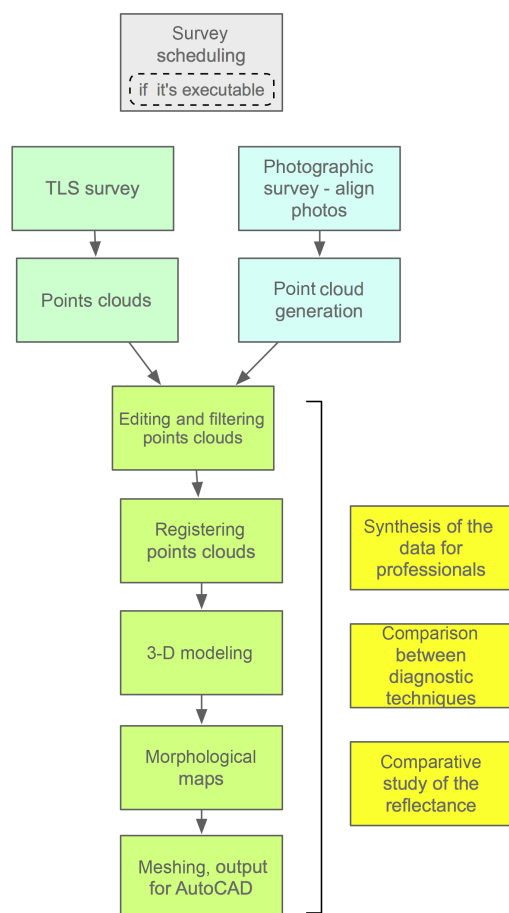
Figure 3. Flow chart of TLS and Photogrammetry data acquisition and processing.

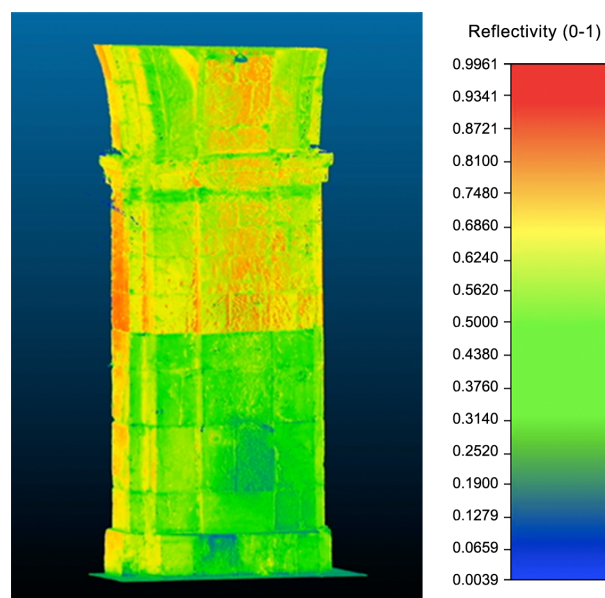
Figure 4. Reflectivity map of the pillar from TLS survey (elaborated with CloudCompare). The pillar was built with different stone materials: lower part with Pietra Forte, upper part with Pietra Cantone.

The aggregated filtered and unstructured point clouds (3-D models) of the pillar obtained with photogrammetry and TLS methodologies were post-processed in order to compare the surface texturized with the reflectivity and the RGB (Red, Green, Blue) colors and the difference of the position of the pixels detected with the two techniques. In fact, the reflectivity map of an object provides preliminary information on construction materials, because different surfaces display different colours (Fig. 4).

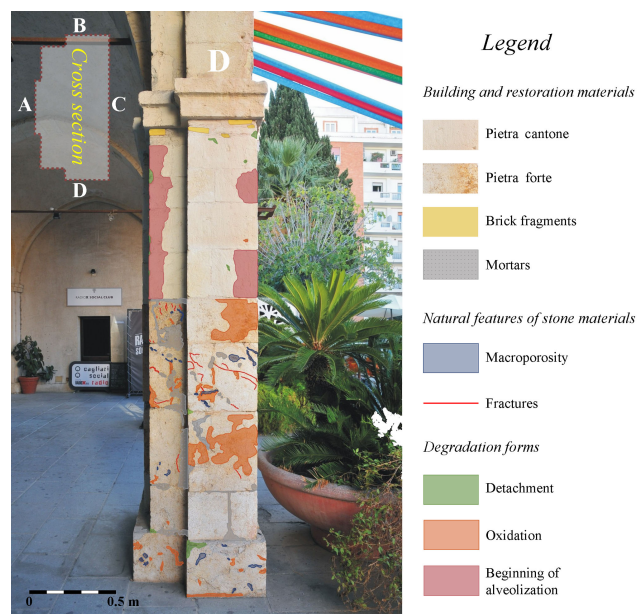
Figure 5. Map of the characteristics of the shallow building materials in one of the investigated faces of the pillar.

The pillar under study is made mainly from Pietra Forte and Pietra Cantone and subordinately from isolated fragments of bricks and different types of mortars used both to fill the joints and as restoration material (Fig. 5). The above

carbonate materials are subject to different degradation and alteration forms, such as alveolization and pulverization in Pietra Cantone and oxidation in Pietra Forte. In the latter natural defects such as fractures and macroporosity are also present (Fig. 5).

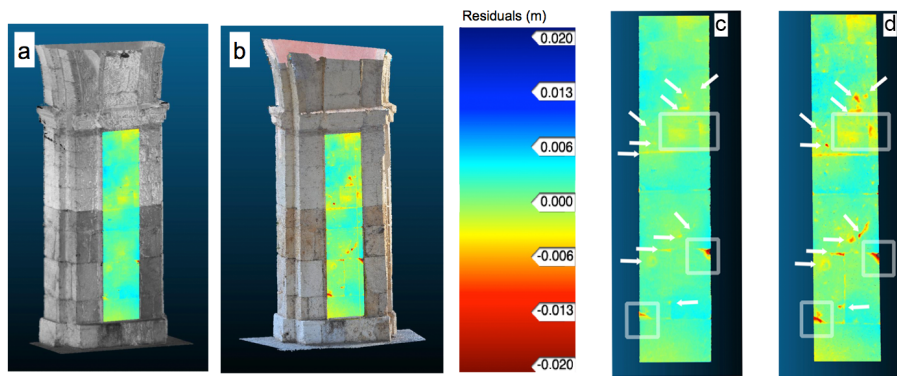
Figure 6. Geometrical anomalies of the columns: the colors represent the residuals in meters inferred by the geometrical anomalies of the aggregated point cloud with respect to a fitted plane. Left side of the figure: (a) from TLS survey (b) from DCI photogrammetric survey. Right side of the figure: (c) geometrical anomalies only by TLS survey; (d) overlapping of the TLS survey and the DCI photogrammetric survey. The similarities are highlighted by the white arrows and the box, the anomalies are more perceivable thanks to the overlapping of the two techniques. This result indicates that the combination of the different methodologies can improve the detection of defective parts (JRC 3-D Reconstructor[®], CloudCompare).

Thanks to the TLS survey and high resolution photogrammetry it was possible to obtain accurate 3-D models that show geometrical anomaly maps with interesting analogies (Fig. 6). The reflectivity map together with the computed map of the geometrical anomalies allowed to highlight the irregularity and the characteristics in the shallow building materials and to locate restoration works performed in different periods in the past. The results of the TLS reflectivity and the RGB texturized surveys can be examined also considering the results of the SEM and optical microscopy analyses. In particular, as highlighted by the white boxes and arrows in Fig. 6, many defective areas (shown in yellow/red in the figure) are present in the surface of the pillar both in correspondence of the junctions of the stone blocks and macroporosity in the Pietra Forte ashlar and where fissures are visible. These irregularities are evident both in the TLS anomaly map and in the photogrammetric map post-processed with Cloud Compare software (Fig. 6).

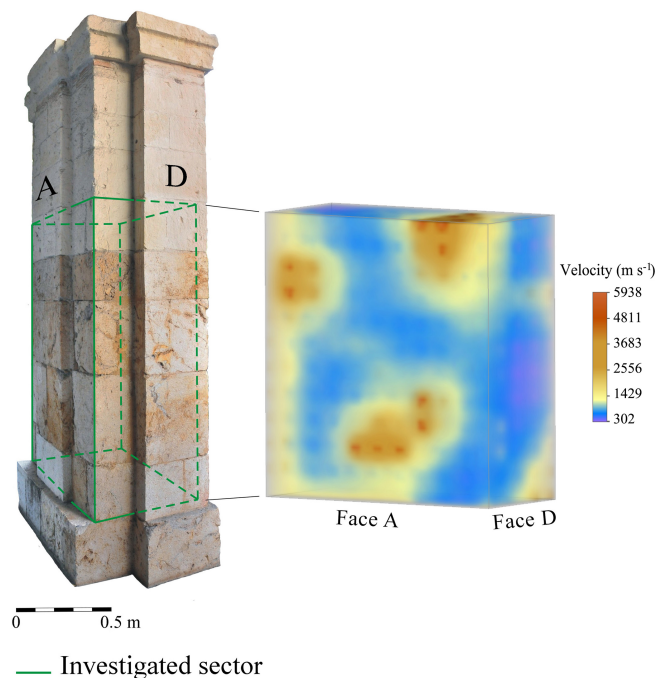
Figure 7. 3-D ultrasonic tomography results for the investigated sector of the pillar.

The 3-D ultrasonic tomography (Fig. 7) gives images of the interior of the pillar built with the same carbonate materials as the outer ashlar. The ultrasonic longitudinal velocity in the investigated inner sector presents a great variability between 350 and 5900 m s⁻¹ denoting a wide variability in the elastic characteristics of the carbonate building materials. The differences in the elastic characteristics of the investigated materials are in part due to the significant differences in their textural and petrophysical features. The elastic characteristics proved to be heterogeneous and generally poor due to the presence of macropores (e.g. small karst cavities) and fractures in the Pietra Forte ashlar and to alteration in the Pietra Cantone. Furthermore, considering that the pillar is a compression element and that the longitudinal velocity increases as compression increases (Knight and Endres, 2005), from the analysis of the 3-D tomography results it cannot be excluded that the variability in the velocity distribution in the interior of the pillar, could also be influenced by a non-homogeneous load distribution.
