# Identifying unstable rock blocks by measuring micro-tremors and vibration on cliffs

Landslide Research Team, Erosion and Sediment Control Research Group, Public Works Research Institute, Japan

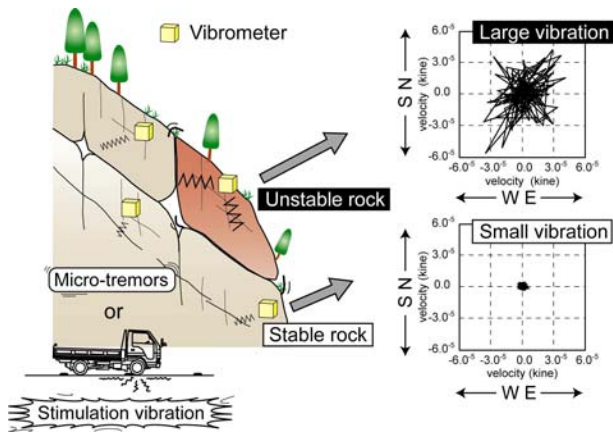
Fig. 1. Image of this measuring method

Hence we carried out a field test to develop a method of simply and precisely identifying unstable rock blocks by measuring vibrations of a rock cliff. This method of identifying unstable rock blocks is based on the idea that in contrast to stable rock in which surrounding cracks adhere closely and are integrated with the foundation, in unstable rock blocks, the cracks have opened and deteriorated, causing separation from the foundation, with the result that unstable rock vibrates more than stable rock (Fig. 1).

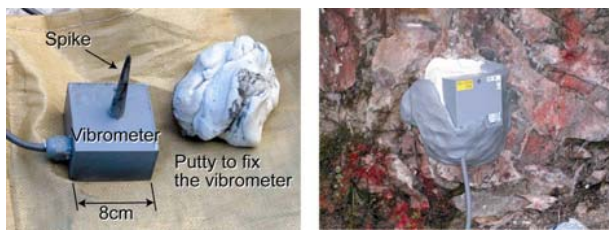
Fig. 2. Vibrometer shape and its installation.

search Team, Erosion and Sediment Research Group, 2007). At this time, the amplitude of vibrations applied to the cliff is not constant, so in principle, one measurement point is set on a known stable baserock to measure its vibrations. The vibrometers that are used can measure vibrations in three dimensions, and their size is approximately  $8 \times 8 \times 4$  cm. Each vibrometer is equipped with an approximately 8cm long spike and is installed by drilling a hole in the rock, inserting the spike in the hole, then fixing it in place with putty (Fig. 2). They are installed by rock climbers (Fig. 3).

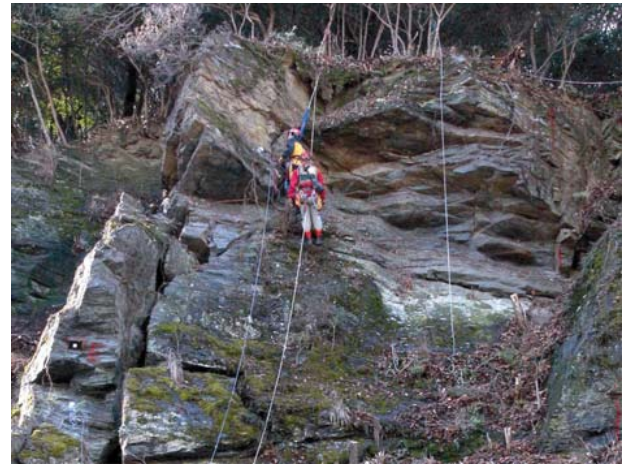
Fig. 3. A rock-climber installing vibrometers.

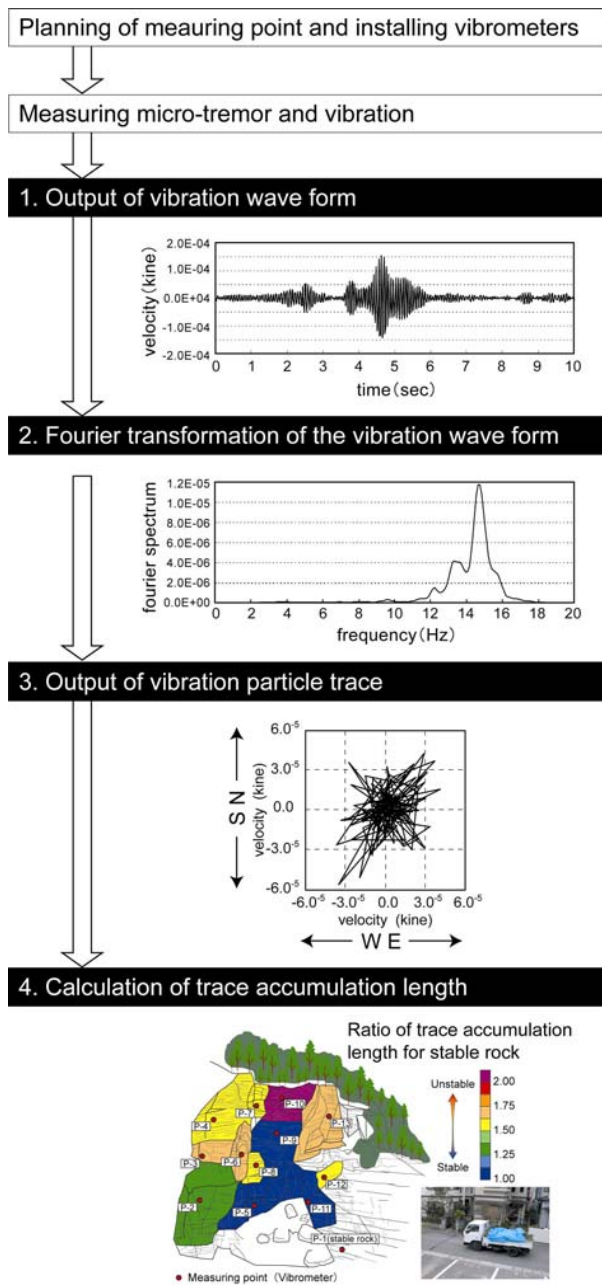
Fig. 4. Flow of analysis.

The vibration that has been measured is analyzed to evaluate the stability of rock blocks as shown in Fig. 4. First, the vibration wave form is output and its amplitude and the way it declines, and other characteristics are visually observed to judge the instability at the measurement point. Secondly, a Fourier transformation of the vibration wave form is performed to obtain the frequency spectrum. The results of the frequency spectrum analysis are applied to judge whether or not measurement points are on the same rock block, based on characteristics such as the existence/non-existence of a dominant frequency, its value, etc. Third, because the vibration is measured in three dimensions, combinations of two dimensions are formed to output the vibration particle trace in a total of three directions: one horizontal direction and two vertical directions. The vibration particle trace visually shows

the amplitude of the vibration, but also permits observation of the direction of the vibration and allows the evaluation of the instability of each measurement point accompanied by a judgment of whether or not they are on the same block. Fourth, trace accumulation length (cumulative length of the trace of the vibration of a measurement point within a fixed period of time) is obtained to represent the vibration amplitude numerically based on the vibration particle trace. This value is used to establish the priority of relative instability of unstable blocks. Trace accumulation length is a new concept applied by this measurement technology, and is a value obtained by accumulating the lengths of traces moved by vibration at the measurement points on rock during a fixed period of time.

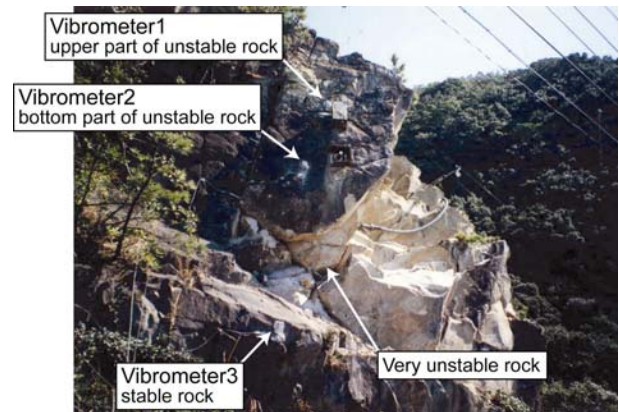
Fig. 5. Situation at Site A.

In Site A where overturning type rock failure had actually occurred, the relationship between the stability and vibration properties of rock blocks was surveyed (Asai et al., 2003, 2005). Figure 5 shows the state of the rock cliff and the layout of the vibrometers. The rock blocks are composed of sandstone that is about 4 m high, 2.5 m wide, and 1 m thick, and there are open cracks on their back surfaces. During the test, the bottom of the rock block was destabilized by crushing or the rock bloc was stabilized by pushing it towards the mountain to artificially vary the stability of the rock block and to measure the rock vibrations under each state. The vibrometers were installed at two locations at the top and bottom of rock block and at one point on stable rock.

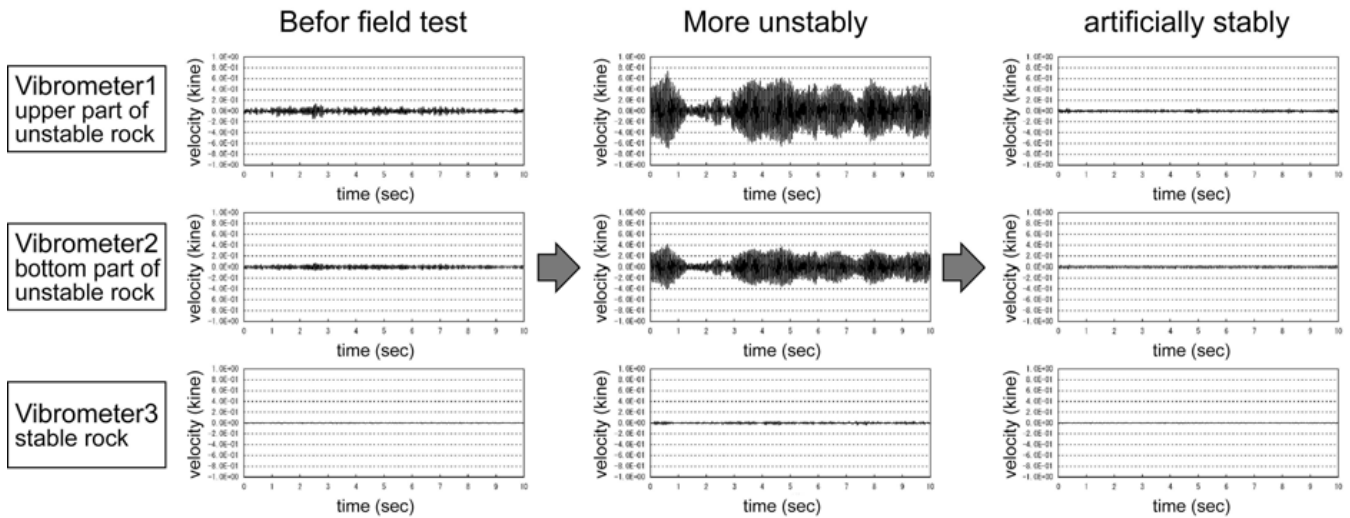
Fig. 6. Relationship between rock stability and vibration.

Figure 6 shows the normal micro-tremors before the rock block was destabilized and when its stability was varied.

When the rock block was destabilized, its vibrations were greater than in its previous state. Later when the rock block was stabilized, its vibrations fell.

This demonstrates there is a correlation between the stability and the vibration properties of the rock block, so that it is possible to evaluate the stability of a rock block by analyzing the state of its vibrations.

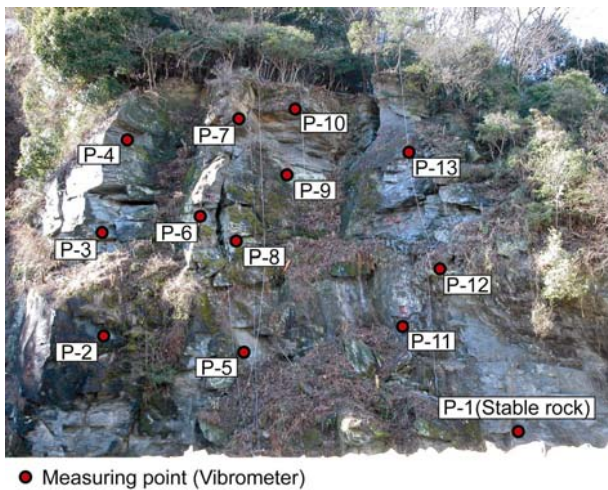
Fig. 7. Situation at Site B.

In Site B, vibration measurements were done in order to identify unstable rock blocks (Asai, 2004). This rock cliff is at risk of rock failure so preventive measures must be taken. The rock cliff that is made of crystalline schist is divided into many blocks by horizontal cracks formed by the joint faces and vertical cracks at right angles to the horizontal cracks. It was hypothesized that it includes many unstable rock blocks. Figure 7 shows the state of rock cliff and the layout of the measurement points. The measurements were done by installing measurement points at a total of 13 locations, including stable rock (P-1) installed on the lower right so that the major rock blocks are encompassed. The measurements were performed to measure normal micro-tremors and vibrations produced by artificial vibrations applied by the passage of a two-ton truck and by an oscillator.

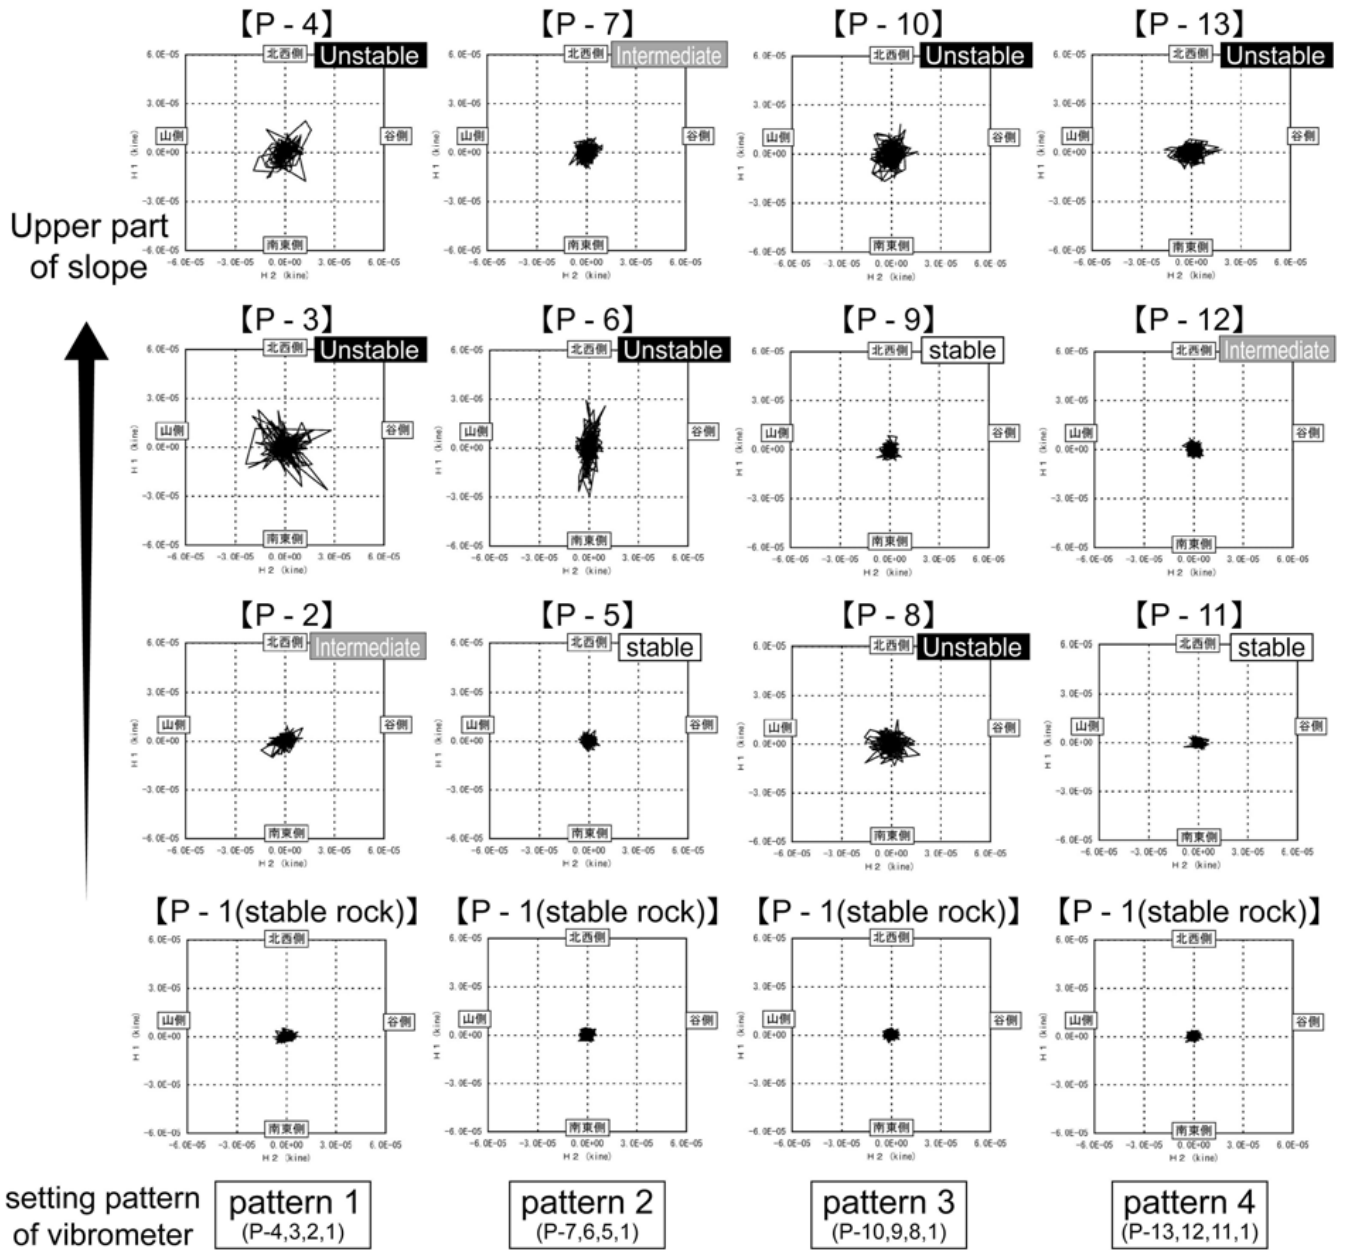
Fig. 8. Results of measuring vibration particle traces.

The results of the measurements when vibrations were applied artificially by the two-ton truck are shown. Figure 8 shows the plane vibration particle trace. And Fig. 9 shows the ratios of the trace accumulation lengths obtained from the vibration particle traces for the other rock blocks with the value for the stable rock block (P-1) as the reference value.

1. P-5, P-9, and P-11 are stable, because the fluctuation of those vibration particle traces are small similarly to that of the stable rock blocks (P-1) (Fig. 8). Also the ratios of trace accumulation length for stable rock are low for those blocks (Fig. 9).
2. P-3, P-4, P-6, P-8, P-10, and P-13 are unstable, because the fluctuation of those vibration particle traces are large compare to that of the stable rock blocks (P-1) (Fig. 8). Also the ratios of trace accumulation length for stable rock are high for those blocks (Fig. 9).

3. P-2, P-7, and P-12 are intermediate state (between stable and unstable), because the fluctuation of those vibration particle traces are likely small as to that of the stable rock blocks (P-1) (Fig. 8), but the ratios of trace accumulation length for stable rock are intermediate for those blocks (Fig. 9).

And if the rock blocks are integrated, the directions of their vibrations are harmonized. Therefore, judging from the dominant vibration direction of the vibration particle trace shown in Fig. 8, at P-3, P-6, and P-8, there were unstable rock blocks separated from the rock blocks above them. A detailed survey of the Site was done, confirming that at P-3, P-6, and P-8, there were clearly opened cracks on the front

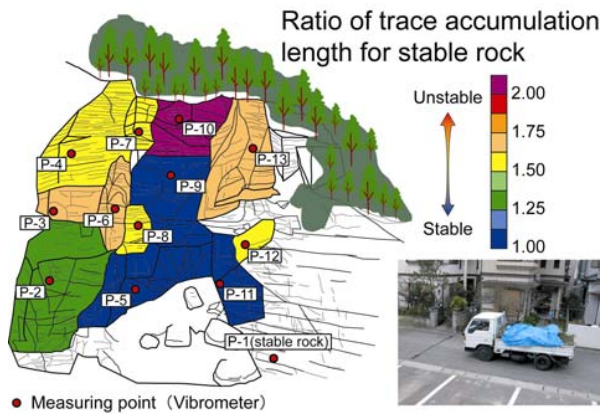
**Fig. 9.** Distribution of unstable rock blocks estimated by simulation waves.

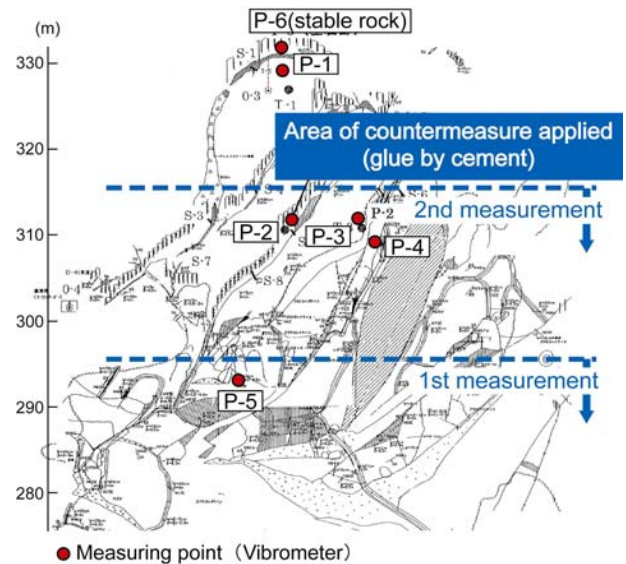
**Fig. 10.** Situation at Site C.

On a rock cliff in Site C, bonding material was injected into open cracks on the unstable rock block. On this cliff, vibration was measured before and after this was done in an attempt to make a judgment of the effectiveness of this countermeasure by this method (Asai, 2005). Figure 10 shows a sketch of the rock cliff, the state of progress of the countermeasure work, and locations of measurement points (P-1 to P-6). The measurements were performed once when the countermeasure was completed to above P-5 and a second time when it was completed to above P-2.

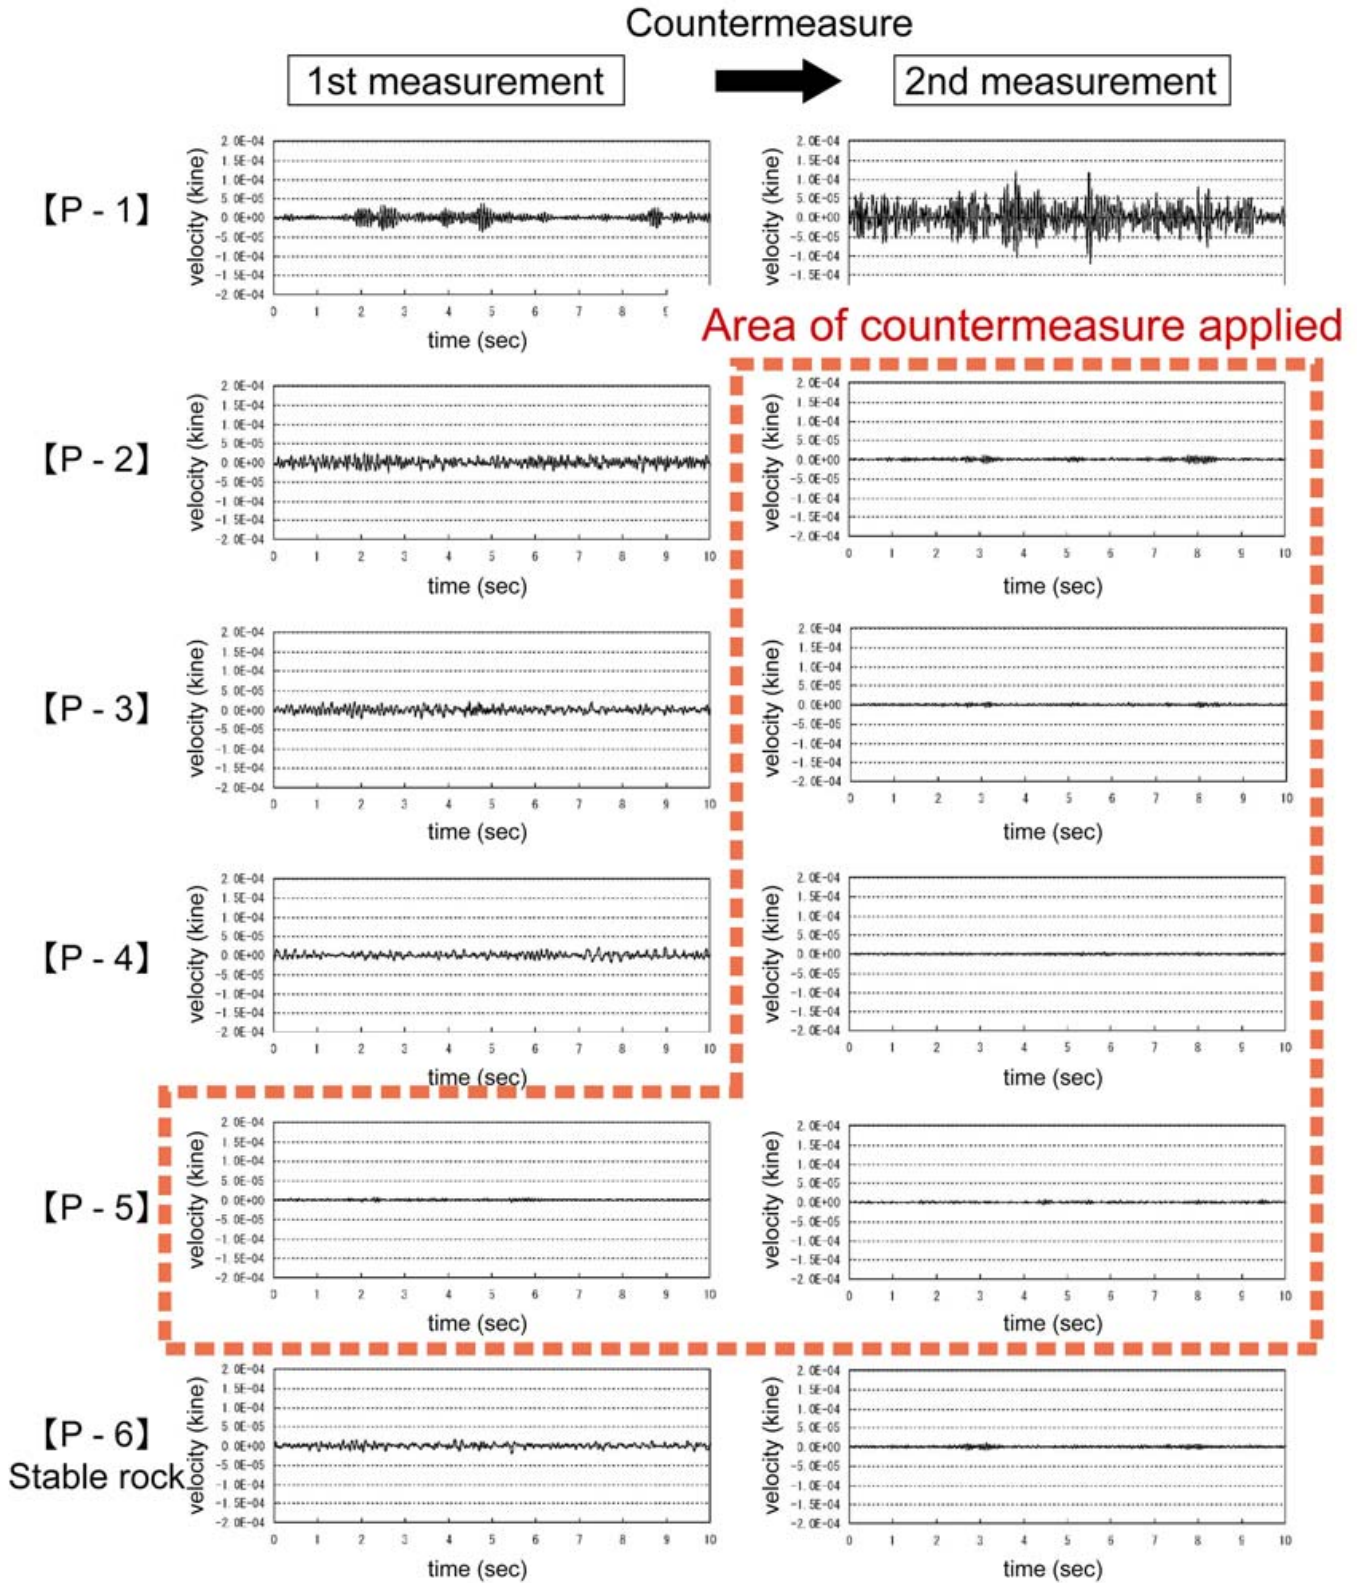
Fig. 11. Vibration wave forms when a countermeasure passed.

Figure 11 shows the wave form when a vehicle passed. The first measurement showed small amplitude at P-5 where the countermeasure was already completed, and the further up the cliff the measurement points – from P-4 to P-1 – the larger the amplitude. In contrast, the second measurement shows that the amplitude at P-2 to P-4 where the countermeasure was newly taken was small as at P-5. But, at P-1 where the measure was not taken, the amplitude continued to be large.

For the above reasons, the fluctuation of the amplitude of rock vibration that was measured is in harmony with the state of progress of the countermeasure, and its effectiveness can be judged by measuring amplitude.
